ANDERSON ENGINEERING INC SPRINGFIELD MO

**HILLIARD ESTATES LAKE DAM  
GREENE COUNTY, MISSOURI  
MO 20473**

**PHASE 1 INSPECTION REPORT  
NATIONAL DAM SAFETY PROGRAM**

**MARCH, 1981**

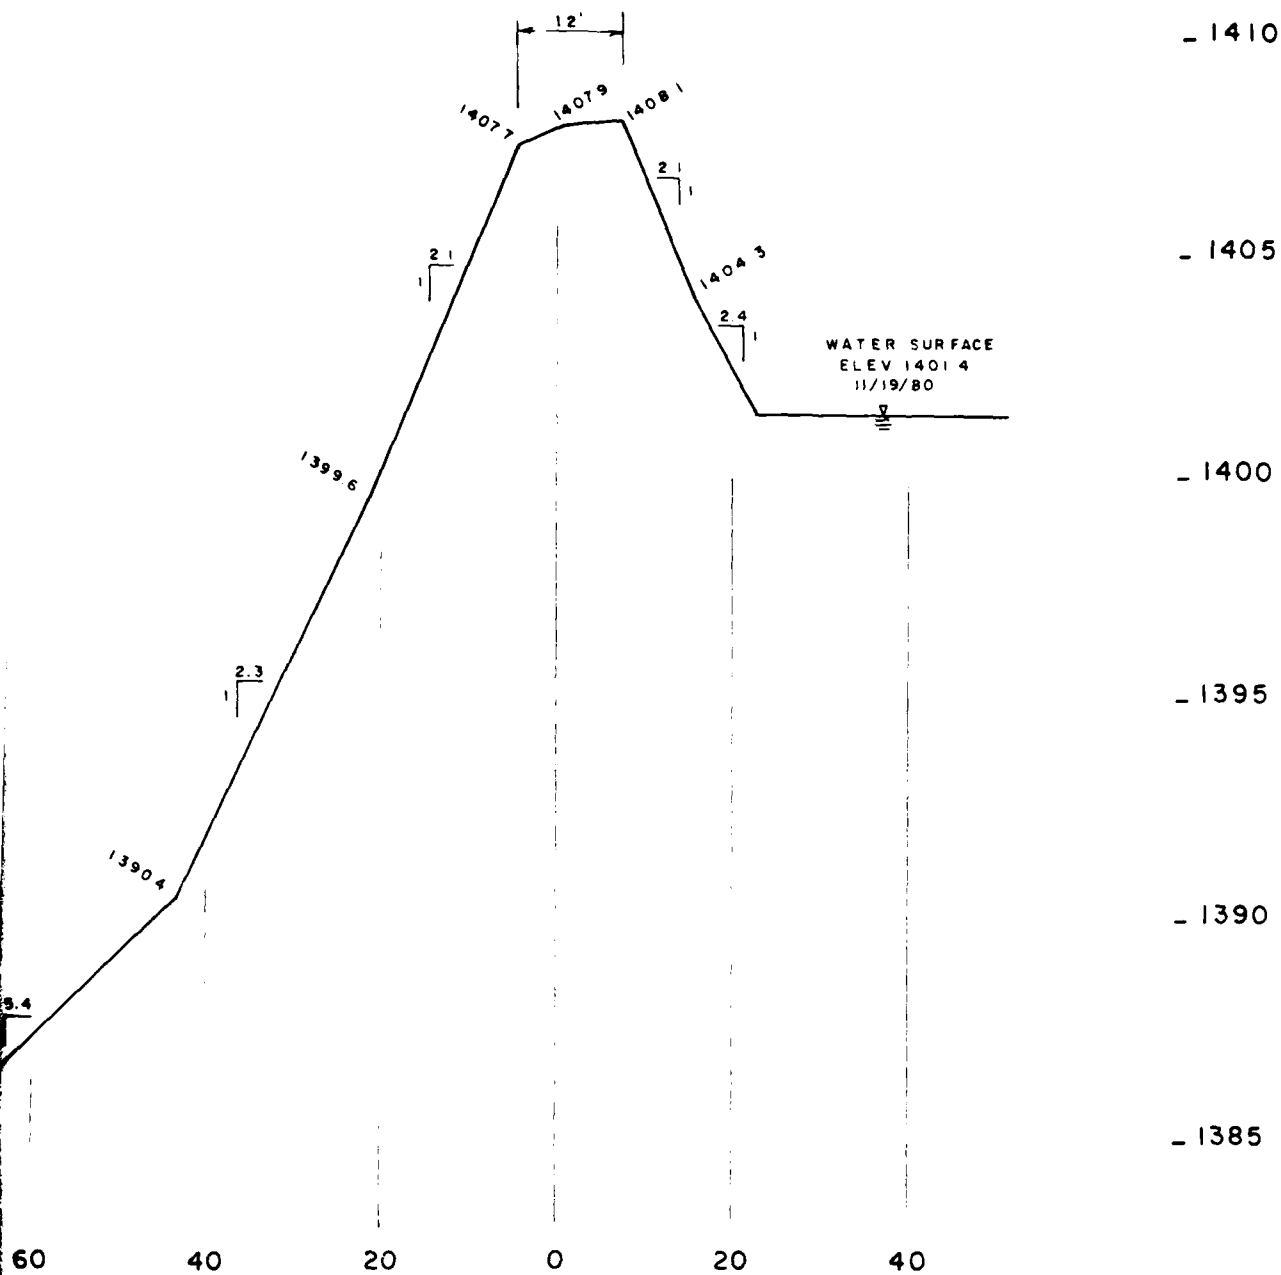
SECTION A - A STA 2+00

The vertical alignment of the crest appeared good. A gentle slope downward in both directions from Station 2 + 00 was noted. The embankment was constructed with a gentle curve concave downstream.

The upstream slope of the embankment varied from 1V on 2.1H to 1V on 2.4H. A good grass cover was noted on the upstream slope. No rip rap was observed on the upstream slope. No significant erosion was noted.

Good grass cover was noted on the downstream slope of the embankment, except for the area adjacent to the embankment toe. The downstream slope of the embankment varied from 1V on 2.1H to 1V on 5.4H. No sloughing or significant erosion of the slope was noted.

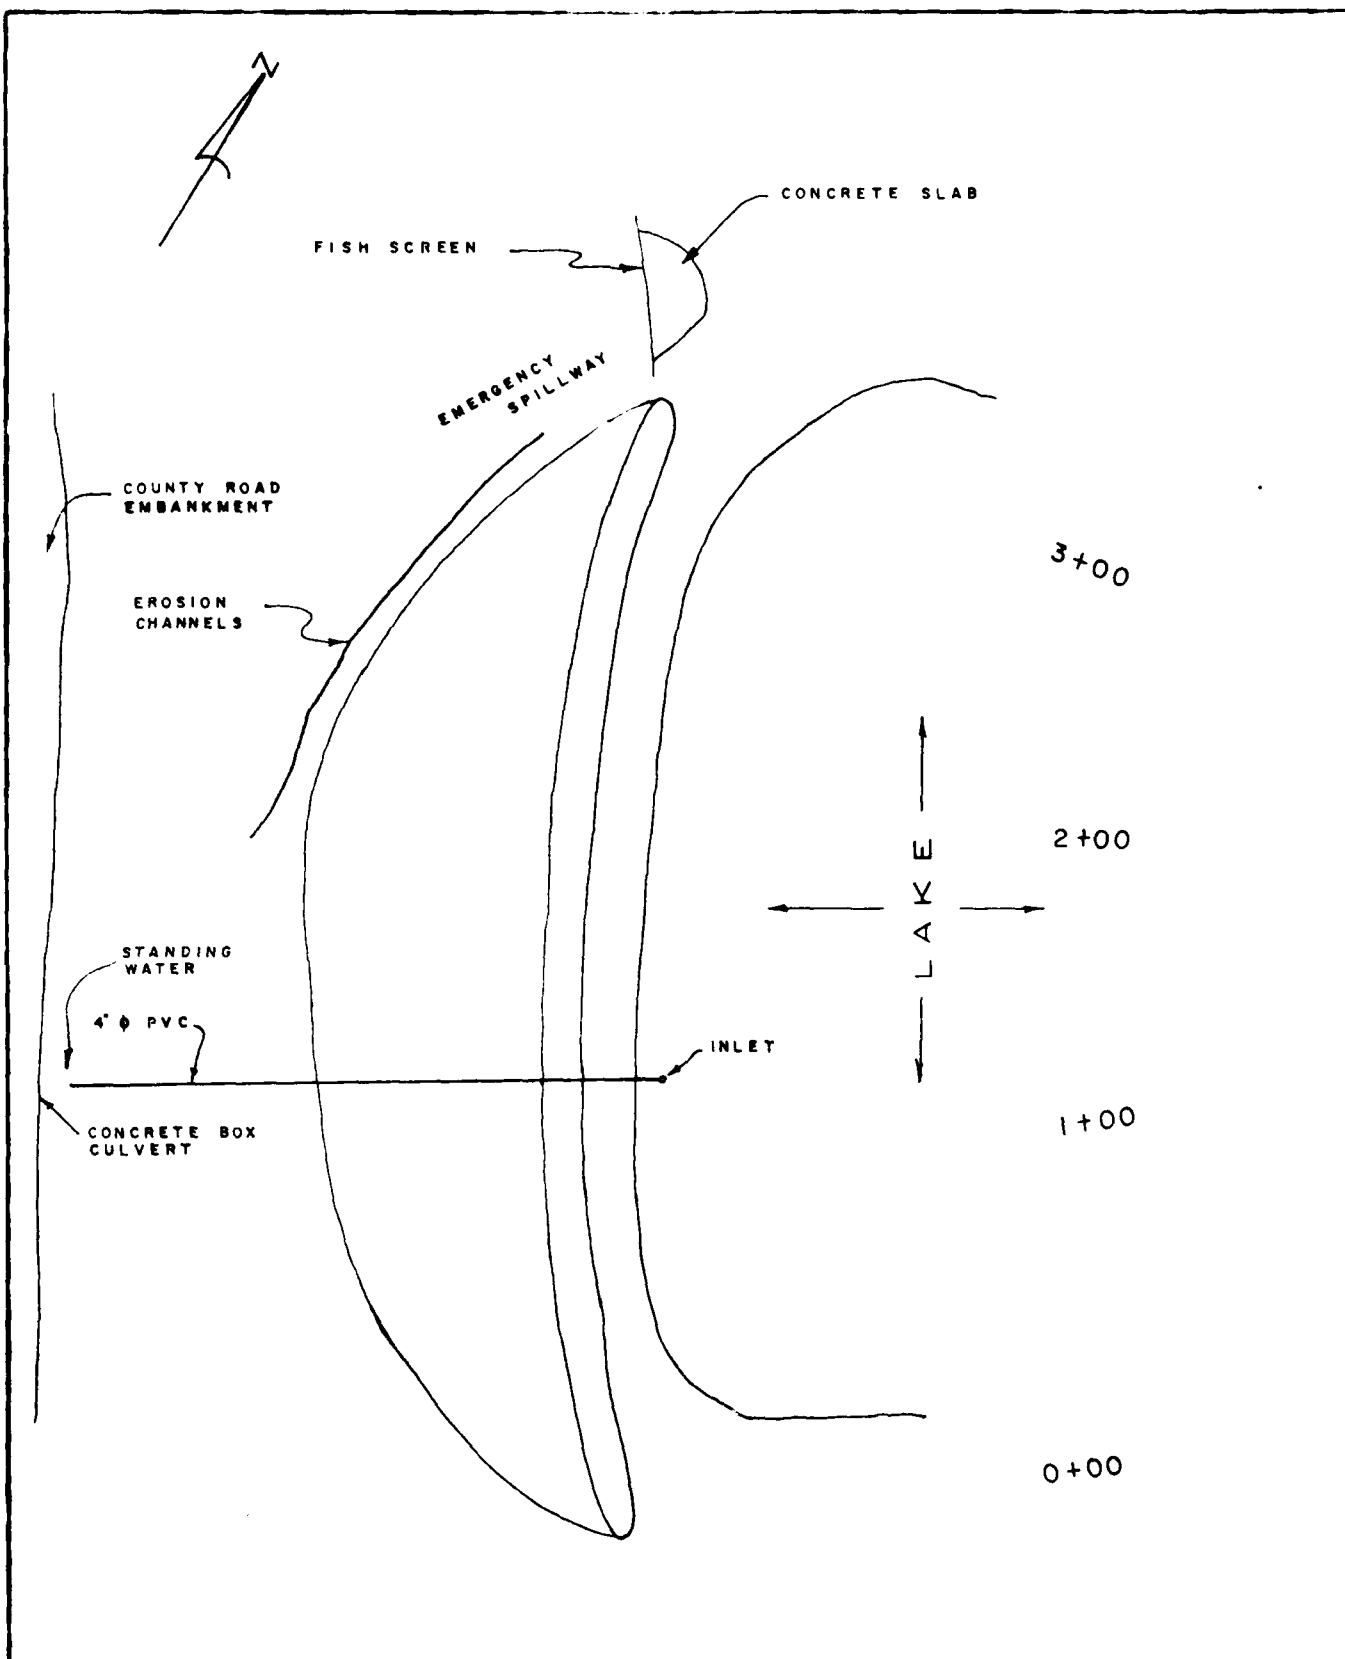
PLAN SKETCH OF DAM  
HILLIARD ESTATES LAKE DAM  
GREENE COUNTY, MISSOURI  
MO. I. D. No. 20473

The contact between the south abutment and the embankment was good. Erosion channels were noted at the north abutment and embankment contact. The erosion was due to the emergency spillway discharges along the toe of embankment.

- (3) The erosion channels along the north abutment-embankment contact should be repaired and maintained. Continued flows through the emergency spillway along the juncture point could seriously impair the structural stability of the embankment.
- (4) Wave protection, such as rip rap, should be provided along the upstream slope of the embankment.
- (5) A detailed study of the long term ponding effects of the downstream roadway embankment should be investigated by an engineer experienced in the design and construction of dams. Remedial measures may be required.
- (6) A detailed inspection of the dam should be made periodically by an engineer experienced in the design and construction of dams.
